Thermal Effects on Compressive Strength of Local Limestone and Claystone

Rahel K. Ibrahim¹, Nawzat R. Ismail² and Hemn M. Omar²

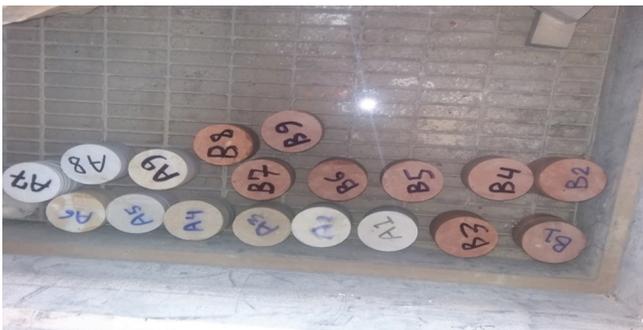
Fig. 2. Eighteen Different Core Samples Collection from Limestone and Claystone of Fatha Formation for Laboratory Tests.

Eighteen outcrop samples of limestone and claystone were taken from three locations of Fatha Formation. The samples were cut by the use of core cutting machine. After cutting, the two circular surfaces of the specimens were straitened by an electrical saw. All the samples were cut to have a cylindrical shape of 7.5 mm in diameter and 14 mm height. The core samples were coded and immersed in a water tank for 24 h (Fig. 2).

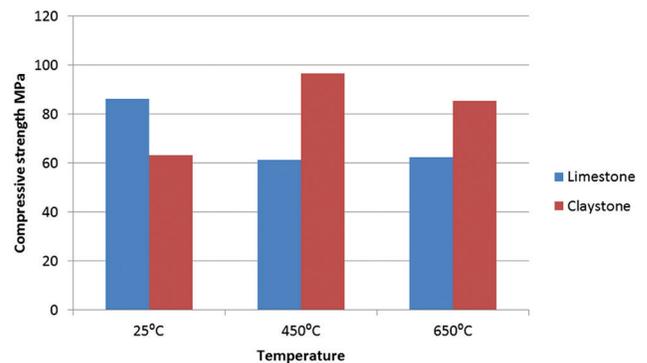
Fig. 3. Compressive Strength for Limestone and Claystone Cores Exposed to Different Temperatures.

average value of compressive strength for limestone ranges from 61.37 to 86.32 MPa, whereas for claystone, the value ranges from 63.17 to 96.6 MPa. The uniaxial compressive strength of limestone and claystone falls within the range of high strength according to New Zealand Geotechnical Society, 2005. Field description of soil and rock, New Zealand: Publication of NZ Geotechnical Society. Statistical models were generated to relate the mechanical properties with the physical properties.

The compressive strength and relative compressive strength for limestone cores exposed to different temperatures are shown in Figs. 3 and 4, respectively. Exposing limestone cores to 450°C resulted in a significant decrease in compressive strength, the strength dropped from 86.32 to 61.37 MPa. The compressive strength of cores after exposure to 650°C was 62.27 MPa which remained approximately similar to that of 450°C. The exposure to high temperature resulted in approximately 30% strength reduction with respect to non-heated samples. This phenomenon is highly due to the transformation of calcium carbonate to lime CaO by the effect of high temperature as stated by Koca, et al., 2006. Moreover, the vapor pressure due to temperature rise inside the specimens causes micro and visible cracks which in turn reduce the compressive strength.

The compressive strength and relative compressive strength results for claystone cores after exposure to high temperatures are shown in Figs. 3 and 4, respectively. The claystone specimens after exposure to 450°C exhibited a considerable increase in compressive strength. The strength rise was around 40%, and it rises from 63.17 MPa for non-heated specimens to 96.6 MPa for those exposed to 450°C. The compressive strength of 85.4 MPa was recorded for claystone cores after exposure to 650°C; this recorded value is around 13% less than the strength of specimens

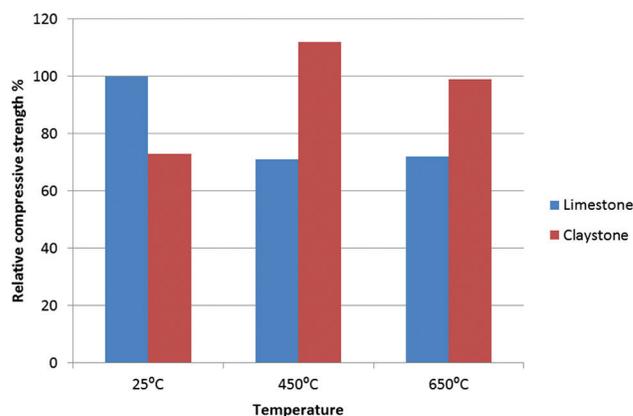
Fig. 4. Relative Compressive Strength for Limestone and Claystone Cores Exposed to Different Temperatures.

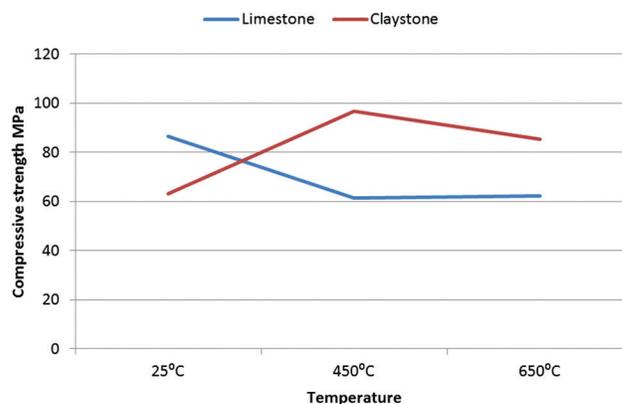
Fig. 5. The Strength Trend Curves for Limestone and Claystone before and after Exposure to High Temperature.

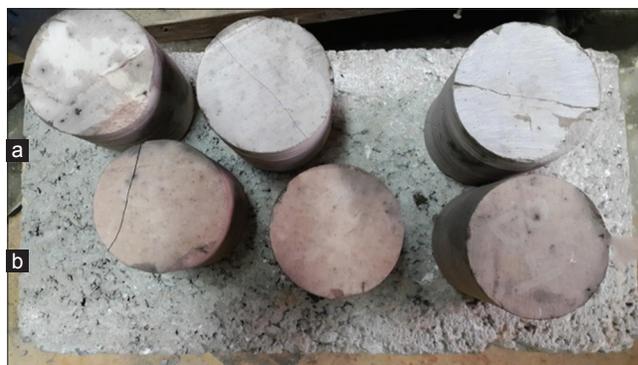
Fig. 6. Cracks in Limestone (a) and Claystone (b) Generated due to High Temperature.

The exposure to high temperatures caused obvious cracks in both limestone and claystone samples (Fig. 6). Limestone samples were more susceptible for cracking than the claystone ones. By increasing the exposure temperature, the color of the samples became lighter. This phenomenon is highly due to losing moisture and the decomposition of materials at high temperatures.

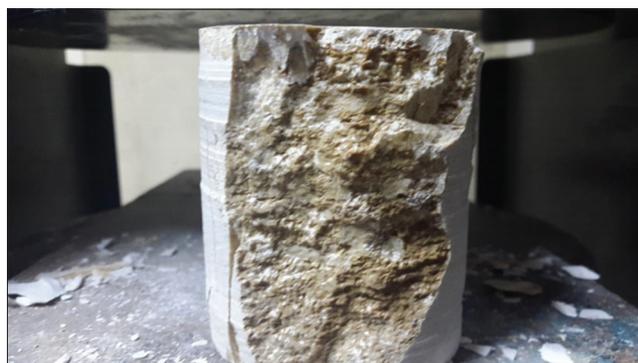
Fig. 7. Limestone Core Sample show Deformation due to Exposure to 650°C.

Fig. 7 shows the limestone sample after exposure to a high temperature of 650°C. From the figure, the decomposition of calcite to free lime can be concluded.
